GEAR FAILURES GUIDELINE

GEAR FAILURES

- *how to recognize them*
 - *what causes them*
 - *how to avoid them*

Reprinted from MACHINE DESIGN December 7, 1967
Copyright 1967 by The Penton Publishing Co., Cleveland, Ohio 44113

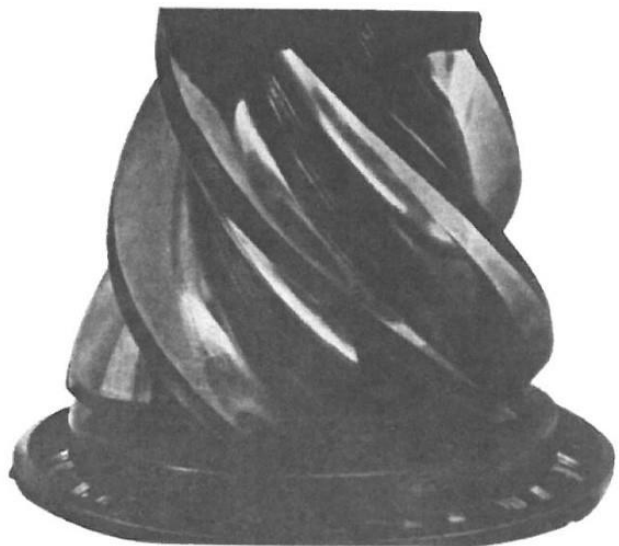
Polishing: Run-in under operating conditions, this hardened hypoid pinion has developed a highly polished surface. Undoubtedly the extreme-pressure additives in the lubricant had a tendency to promote polishing on the tooth surfaces.

Polishing is a very slow wearing-in process in which the asperities of the contacting surfaces are gradually worn off until a very fine, smooth surface develops.

Cause: This condition is usually caused by metal-to-metal contact during operation. Generally, “polishing-in” occurs on slow-speed applications where the elasto-hydrodynamic lubrication film is not sufficiently thick and the gears are operating near the boundary-lubrication regime.

Remedy: Often this condition need not be avoided unless the design life of the equipment is much longer than the predicted wear life based on polishing-in. Polishing gives good conformity of the surfaces.

After the gear is well polished-in, the surface can be protected by substituting a lubricant with a higher viscosity, by reducing the transmitted load substantially, or, in some cases, by increasing the operating speed to obtain a better elasto-hydrodynamic oil film.

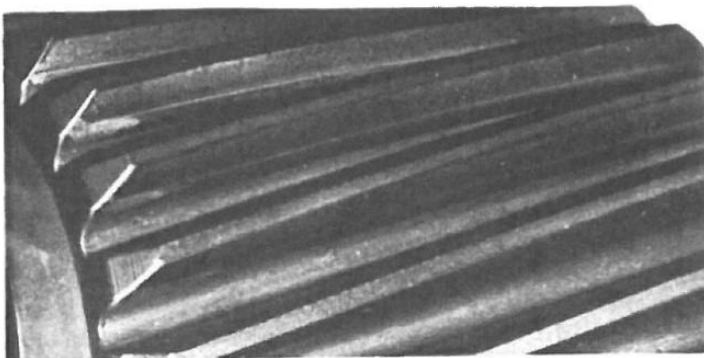
Moderate Wear: The addendum and dedendum sections of these medium-hard gear teeth have worn, causing the operating pitch line to become visible because little if any material has been removed along this line.

The type of wear classified as moderate takes place over a relatively long period of time. The contact pattern indicates that metal has been removed in the addendum and dedendum area; also, the pitch line begins to show as an unbroken line.

Cause: Moderate wear is most commonly caused by an inadequate lubrication film, with the film

thickness being too thin for the load. Dirt in the lubrication system can also cause this type of wear.

Remedy: One solution is to specify a lubricant with a greater film strength, or one with a higher viscosity. Also, the unit can be operated at a greater speed to build up the lubricating film. Finally, a gear material with a higher wear resistance can be specified.

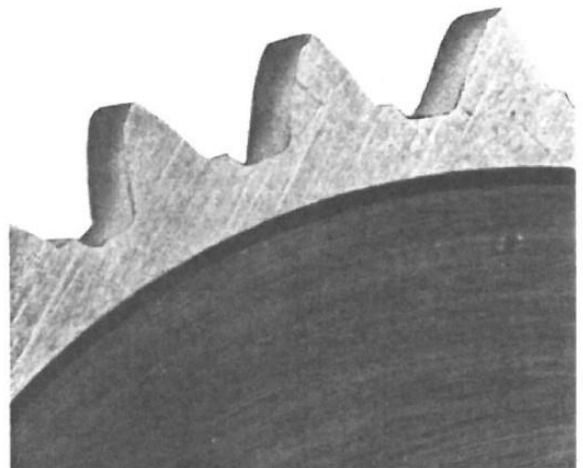
Excessive Wear: Material has been uniformly worn away from the tooth surface causing a deep step. The tooth thickness has been decreased and the involute profile destroyed. Some slow-speed gears can operate on such a profile until so much material has been worn away that the tooth fails under beam bending fatigue.

This is simply normal wear which has progressed to the point where a considerable amount of material has been removed from the surfaces. The pitch line is very prominent and may show signs of pitting.

Cause: This problem is usually caused by the failure to notice early enough that wear is in prog-

ress. When enough material has been worn from the tooth surface, the involute profiles are destroyed and the gears begin to run roughly. The situation is aggravated by the rough running, causing still

greater wear. Eventually the surface is such that the gears are no longer fit for reliable service.

Remedy: This condition could be avoided by using the same methods given for moderate wear—increasing lubricant film strength or viscosity, or increasing pitch-line velocity.

If the gear unit is splash-fed, changing to a positive spray lubrication system with a filter will help keep wear particles out of the gear mesh and ensure that adequate lubricating oil is delivered to the working surfaces.

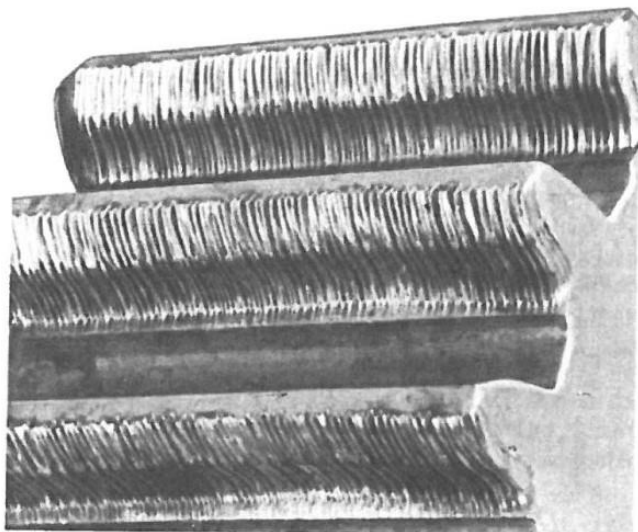
Abrasive Wear: In this extreme case, a large portion of the tooth of the bronze pinion has worn away due to an accumulation of abrasive particles in the lubricant. Note the deep ridges, and the ends of the gear teeth, which were not subjected to the abrasive action.

When abrasive wear has taken place, contacting surfaces show signs of a lapped finish, radial scratch marks or grooves, or some other unmistakable indication that contact has taken place.

Cause: Foreign material in the lubrication system ordinarily causes abrasive wear. The particles may

be metallic debris from the gear and bearing system, weld spatter, scale, rust, sand, etc. Abrasive wear is often noted soon after startup of a new installation, before the filter has had a chance to clean the system.

Remedy: This type of wear can be remedied by the use of a filter or, where a filter is already being used, a finer grade of filter. Alternatively, a higher-viscosity lubricant will develop a thicker oil film, which will pass fine particles without scratching. Of course, the best way to guard against early abrasive wear is to see that the gearbox and lubricating system are carefully cleaned before use.

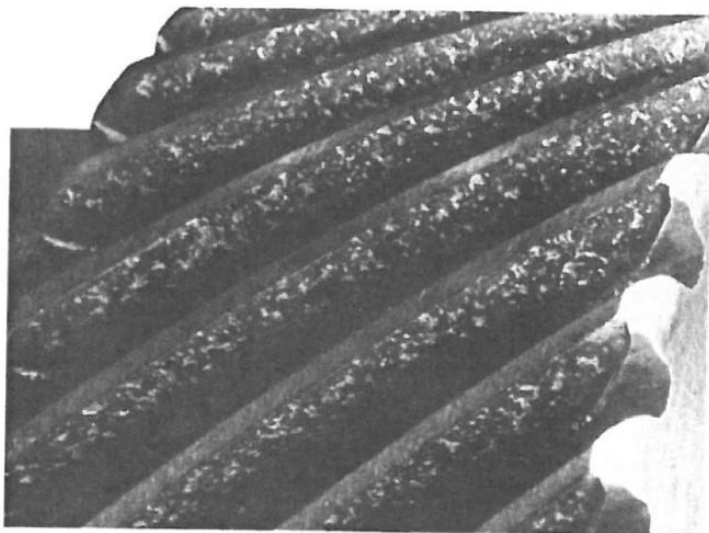
Corrosive Wear: Although considerable wear has taken place, the surface still shows signs of having been attacked chemically. Wear of this nature will continue until the gear surface is beyond usefulness.

This is a deterioration of the surface due to chemical action. It is often caused by active ingredients in the lubricating oil, such as acid, moisture, and extreme-pressure additives.

Cause: The oil breaks down so that corrosive chemicals present in the oil attack contacting surfaces. Often this action affects the grain boundaries, causing fine pitting more or less uniformly over the tooth surfaces. At high temperatures, extreme-

pressure additives sometimes form very active corrosive agents. Lubricants can also become contaminated from absorption of foreign material from external sources.

Remedy: Because they are chemically active, lubricants with high anti-scoring, anti-wear additive content must be kept under careful observation to ensure that they are not attacking working surfaces. By checking the lube oil for breakdown and by changing the lube oil at regular intervals, corrosive wear can be avoided.

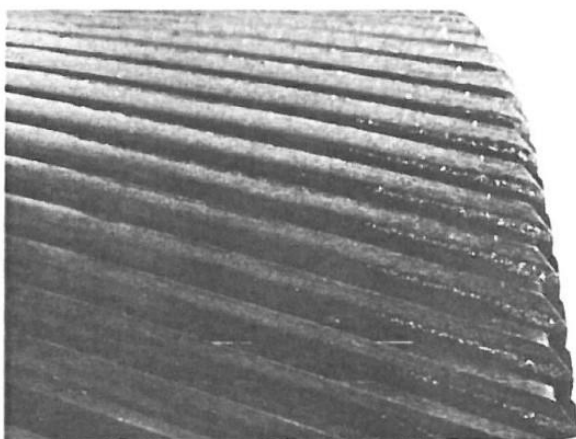
Initial Pitting: Pitting began on the outside end of the helix because of a small amount of misalignment, with pits of small diameter. The pitting worked its way from the end to the middle of the tooth. Eventually pitting stopped and the pitted surface began to burnish over, indicating that the load across the tooth had become more evenly distributed. This type of pitting, often called corrective pitting, is most common in medium hard gears.

This condition is characterized by small pits from 1/64 to 1/32-in. in diameter. Initial pitting occurs in localized, over-stressed areas; it tends to redistribute the load by progressively removing high contact spots. Generally, when the load has been redistributed, the pitting stops and the contact surfaces smooth over.

Cause: Initial pitting is usually caused by gear-tooth surfaces not properly conforming with each other or not fitting together properly. This can

be a result of minor involute errors or local surface irregularities, but most often it occurs because there is not proper alignment across the full face width of the gear mesh.

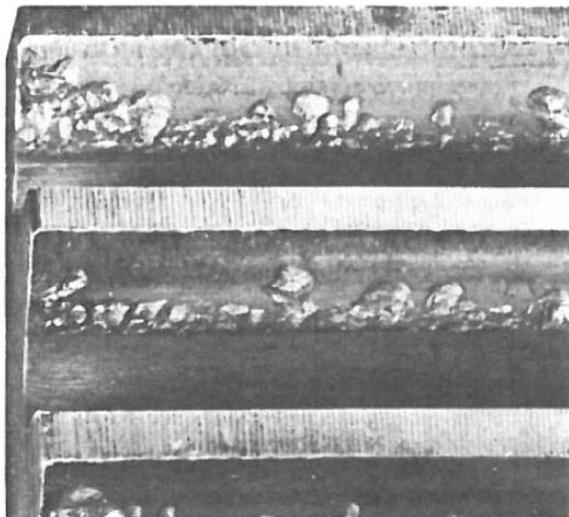
Destructive Pitting: Heavy pitting has taken place, predominantly in the dedendum region. The pitted craters are larger than those in initial pitting. Some pitting has also taken place in the addendum region.

The dedendum section of the drive gear is often the first to experience serious pitting damage; however, as operation continues, pitting usually progresses to the point where a considerable por-

tion of all the tooth surfaces have developed pitting craters of various shapes and sizes.

Cause: Destructive pitting usually results from surface overload which cannot be alleviated by corrective (initial) pitting. Once enough stress cycles have been built up, pitting continues until the tooth profile is completely destroyed, causing extremely rough operation and considerable noise. Often a bending fatigue crack will originate from

a pit, causing a premature tooth breakage failure.

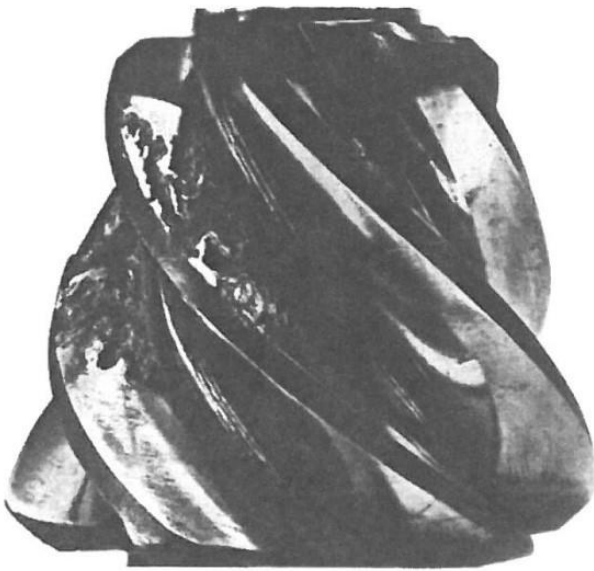
Spalling: This hardened pinion shows an advanced stage of tooth spalling. Material has progressively fatigued away from the surface until a large irregular patch has been removed.

Spalling is similar to destructive pitting except that the pits are usually larger in diameter and quite shallow. Often the spalled area does not have a uniform diameter.

Spalling often occurs in medium-hard material, as well as in highly loaded fully hardened material. Spalling of this kind should not be confused with "case crushing" which is associated with case-hardened gear material.

Cause: Spalling is usually caused by excessively high contact stresses. Usually, large pits are formed; because stress levels are high, the edges of the

initial pits break away rapidly and large irregular voids are formed. Often these voids join together.

Remedy: Contact stress on the gear surface can be reduced below the endurance limit of the material. If the gear material is not hardened, hardening will give the material increased surface strength. Often a complete redesign of the gear elements is best since destructive pitting and spalling are evidence that the gears do not have sufficient surface capacity.

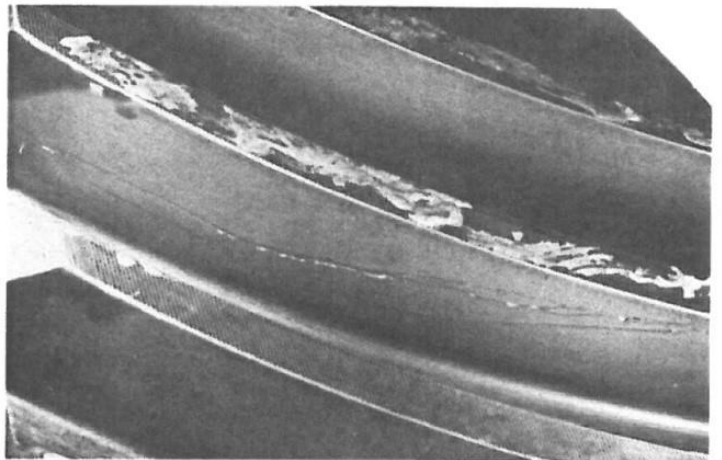
Case Crushing: Several large longitudinal cracks, and several smaller ones, have appeared in the contact surface of this case-carburized bevel gear. The major cracks originated deep in the case-core structure and worked their way to the surface. Long chunks of material are about to break loose from the surface. The cracks should not be confused with normal fatigue cracks, which result from high root stresses and normally form below the contacting face.

Although not considered a pitting failure, case crushing may appear similar in that damage has occurred on the contacting surface. It occurs in heavily loaded case-hardened gears, such as those which are case-carburized or nitrided.

Failure often occurs on only one or two teeth of a pinion or gear; the other teeth appear to be undamaged. Often, longitudinal cracks appear on

Cause: Cracks originate at the subsurface when stresses exceed the strength of the subsurface material. The cracks propagate along the case-to-core boundary and to the surface of the gear tooth. When several cracks reach the tooth surface, large chunks of material are removed. Failures are caused by insufficient case depth or by very high residual stresses in the gear.

Remedy: Failures most often can be overcome by increasing the effective depth of the case material. A change in basic material can be considered—for example, one that produces a hard core material for the same depth of case. Some carburizing materials will produce a 40-Rc core whereas others will only produce 30-32 Rc. This amounts to a considerable difference in strength.

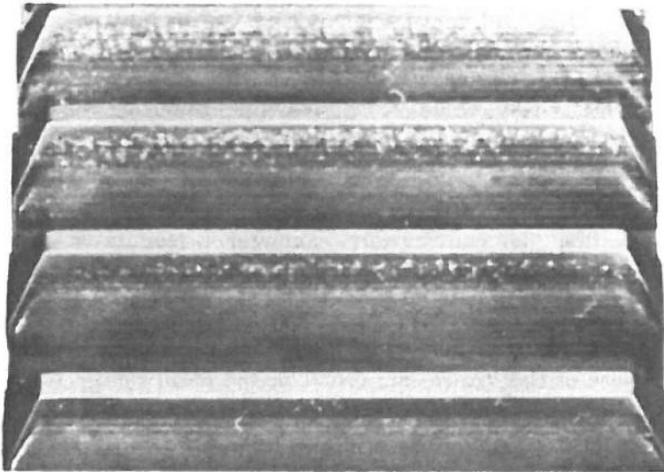
Frosting: This hardened and ground spur gear shows the early stages of frosting. In this case the addendum portion of the teeth shows the spotty frosting pattern. Damage to this gear is negligible at this stage.

Frosting occurs in the early stages of scoring. Usually the dedendum section of the driving gear is the first to show signs of surface distress, although frosting can first show up on the addendum section.

As the name implies, the wear pattern appears frosted. The normal polish of the surface has an etch-like finish. Under magnification, the surface appears to be a field of very fine micro-pits less

than 0.0001 in. deep. The frosted pattern will sometimes follow the slightly higher ridges caused from cutter marks or other surface undulations.

Cause: Frosting is caused by heat in the mesh, which results in only marginal lubrication. The heat of the mesh and the bulk temperature of the rotating gears combine to break down the lubrication film.

Remedy: A very careful break-in cycle is often beneficial. A break-in cycle starting with reduced

speeds and reduced load will condition the gear-tooth surfaces and improve the conformity of the contacting surfaces so that less local heat will be generated because of better load distribution. Reduced oil temperatures or better control of temperature fluctuations will tend to keep the heat level within safe limits. A mild extreme-pressure oil may be helpful but may not be necessary.

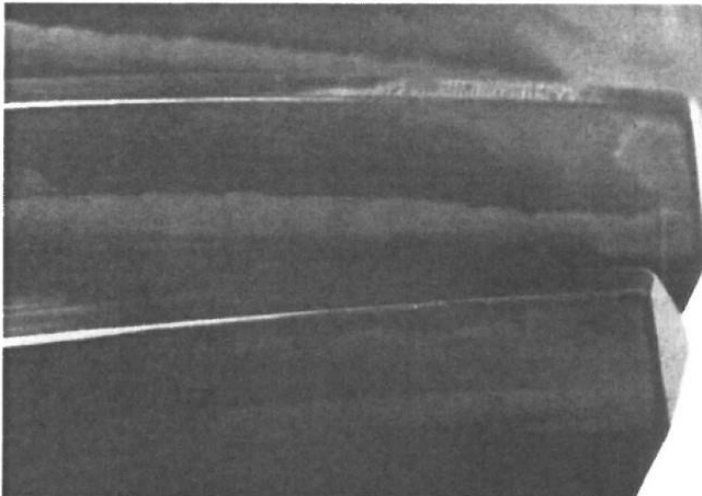
Frosting: This hardened helical gear shows a typical frosting pattern. Note that frosting is predominantly in the dedendum section, although patches do appear in the addendum section. This frosting pattern shows no radial welding and tear marks.

Often, where frosting appears, subsequent operation of the unit will slowly polish away the frosted areas if all operating conditions remain constant.

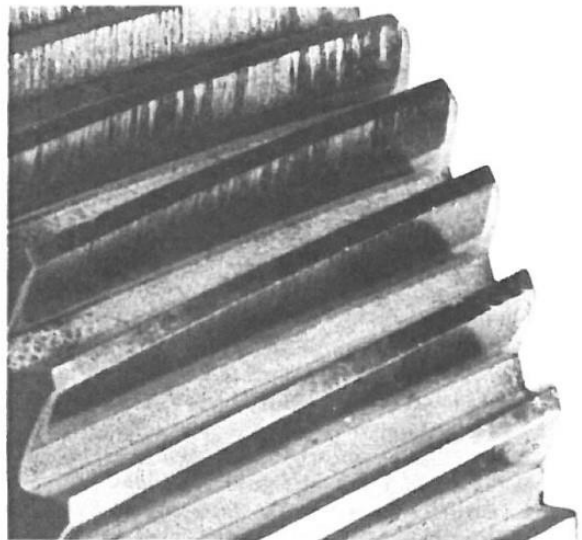
Light to Moderate Scoring: At this stage, scoring has a frosty appearance. On close examination, it can be seen that there has been metal-to-metal contact, and alternating welding and tearing.

In this type of failure, a characteristic wear pattern shows up on the addendum or dedendum (or both) of the gear teeth, often in patches. At times,

there are indications of radial tear marks; however, this is not always the case. Generally, hard gears appear more frosted. Softer gears show some frosted appearance along with fine radial tear marks.

Cause: Excessive heat in the gear mesh causes this condition, causing lubricant breakdown.

Remedy: The obvious remedy is to reduce the amount of heat in the mesh by cutting down on

the load being transmitted or the speed of the rotors, or by reducing the inlet oil temperature, which in effect reduces the bulk temperature of the gear rotors. A lubricant with extreme-pressure additives can be substituted. In some cases, a solid lubricant plated on the contact surface helps prevent the scoring from progressing. Also, honing has found increasing use in guarding against scoring.

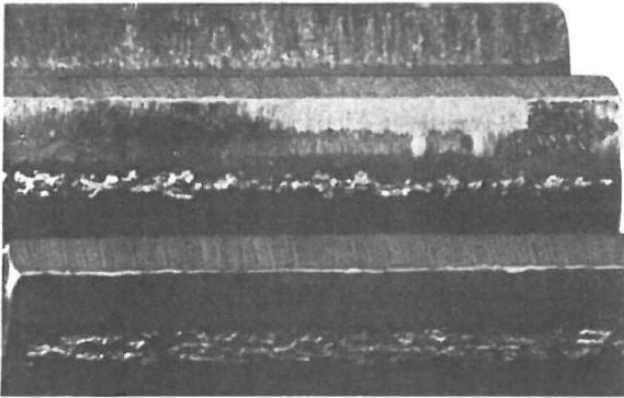
Destructive Scoring: Heavy scoring has taken place above and below the pitch line, leaving the material at the pitch line. As a result, the pitch line pits away as it attempts to redistribute the load. Usually the gear cannot correct itself and ultimately fails.

This type of failure shows definite indications of radial scratch and tear marks in the direction of sliding. Often material has been displaced radially over the tips of the gears. Also, there are indications that considerable material has been removed from above and below the pitch line, and the pitch line itself stands out prominently. The profile is completely destroyed and for all practical purposes the gear is not fit for service.

Cause: This failure is usually caused by inadequate lubrication or by excessive operating temperature, surface load, or surface speed, all of which generate excessive heat. When the lubricant breaks down, the welding and tearing destroys the profile in minutes.

Remedy: The lubricant must be able to stand up under the load, speed, and temperature con-

ditions of the mesh. Extreme-pressure additives are useful. Also, special high-viscosity compounded gear oil will often prevent scoring of this nature. Synthetic fluids with anti-scoring additives will prevent scoring at higher temperature.

In general, a careful analysis of the amount of heat being generated by the mesh is necessary, so that a fluid can be chosen that matches these conditions. If this is not possible, the gear set must be redesigned to reduce surface stresses, mesh losses, pitch-line velocity, and inlet-oil temperature.

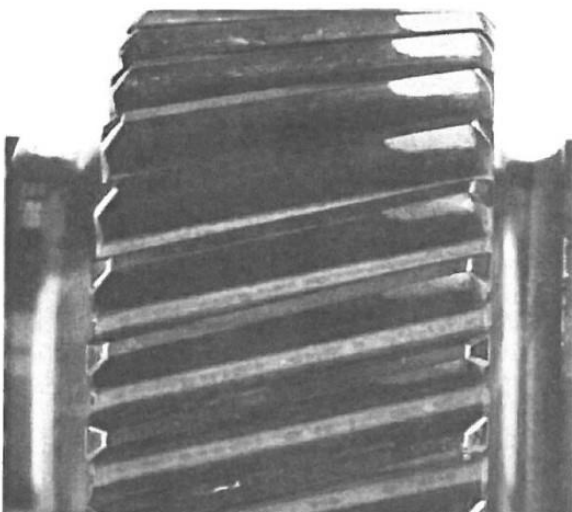
Localized Scoring: This high-speed, high-load helical gear shows localized scoring on the ends of the teeth. This failure was caused by a design oversight: when the gear casing reached operating temperature, differential expansion caused a shift in alignment across the face of the gear. The resulting load distribution caused scoring.

This scoring, similar to moderate scoring, takes place in localized areas along the contacting pattern of the gear teeth. Scoring is usually concentrated in these areas and does not spread across the full face width of the contacting gears.

Cause: Scoring of this nature is usually the result of local load concentrations caused either by design or by unintentional factors such as a misalignment resulting from poor manufacture, deflections under load, or temperature gradients across the face due to non-uniform cooling of the mesh. If the load concentration is near the ends of the teeth, the cause is misalignment, with more load being carried on this portion of the teeth than the lubrication film can support. Sometimes load is concentrated in the center of the gear teeth.

A crown is sometimes used at the center of the tooth to prevent the load from shifting if the design is prone to misalignment under operation. Because of this crown, the center of the tooth carries more load; often the higher load breaks down the lubrication film, permitting metal-to-metal contact and subsequent scoring. Sometimes an "effective crown" can be caused by unequal cooling of the mesh, which in effect causes the diameter of the gear in the center to grow with respect to the diameter of the two ends. Wide-face gears are particularly prone to this difficulty.

Remedy: Scoring failures of this nature can be avoided by eliminating localized loading. If misalignment is present, the gear casing may be deflecting non-uniformly, gear-shaft deflection may be excessive, bores of the casing may be out of parallel, or the gears themselves may be cut with a helix-angle error.

To eliminate localized scoring due to temperature gradients, particular attention must be paid to obtaining uniform heat removal across the mesh. Changes may be necessary in the amount of cooling oil and how it is applied to the mesh. If scor-

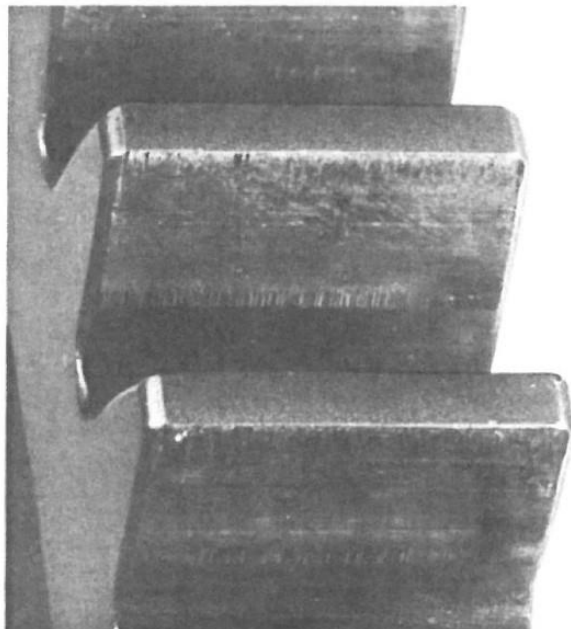
Tip and Root Interference: This gear shows clear evidence that the tip of its mating gear is fouling the root section. Localized scoring has taken place, causing rapid metal removal in the root section. Generally, interference of this nature can cause considerable damage.

In this type of scoring, the deep-dedendum portion of the gear shows definite signs of metal removal and may often show destructive radial scratch marks. Other portions of the contacting face look undamaged. Sometimes the tip of the gear or pinion shows unmistakable signs of metal removal, with the damaged tips having an abraded look and tear marks in the direction of rotation.

Causes: This condition is not entirely dependent

on the normal causes of scoring failure. The tip of the pinion may require tip modification, the root section of the gear may have a profile error, or the gear pair may be running on tight centers. The heavy loading at the tip or root of the mating pair or the interference caused by a tight mesh prematurely breaks down the lubricant film, causing rapid metal removal at the tips and roots and general abrasion of the teeth.

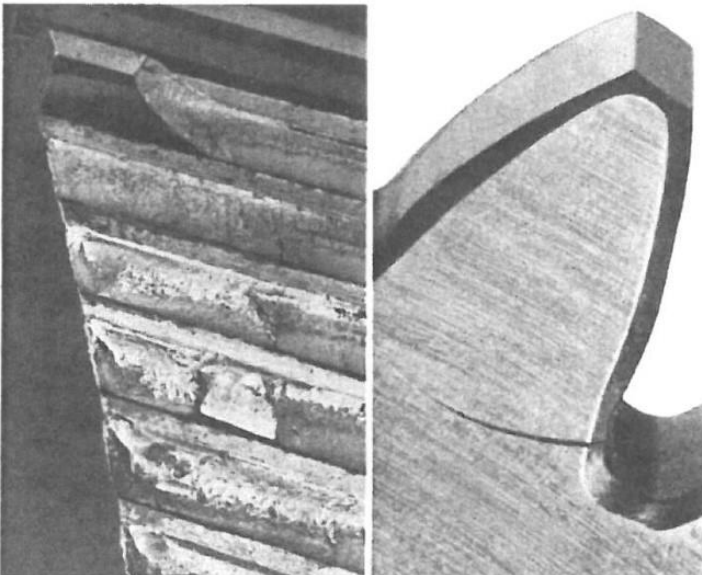
Beam Bending Fatigue: (right) This aircraft power spur gear shows a fatigue crack caused by stresses at the root fillet.

Beam Bending Fatigue: (left) Each failed tooth started at a crack that had been in progress for some time. All the failed teeth show evidence of fretting corrosion and typical beach marks common to this kind of failure. Undoubtedly one tooth broke away first, causing an impact that then quickly broke the remainder of the teeth.

Gear-tooth failure from bending fatigue generally results from a crack originating in the root section of the gear tooth. The whole tooth, or a part of the tooth, breaks away. Most often there is evidence of a fatigue "eye" or focal point of the break. The break shows signs of fretting and conventional smooth beach marks in the break area. Generally there is a small area that shows a rough, jagged appearance, indicating this was the last portion of the tooth to break away.

Cause: The causes of bending fatigue failures are

many. Most failures result from excessive tooth loads, which result in root stresses higher than the endurance limit of the material. When gears are loaded in this manner and subjected to enough repeated stress cycles, the gear tooth will fail.

Sometimes stress risers help to aggravate this condition and subject the gear to higher root stress levels than would normally be predicted. Such risers include notches in the root fillet, hob tears, inclusions, small heat-treat cracks, grinding burns, and residual stresses.

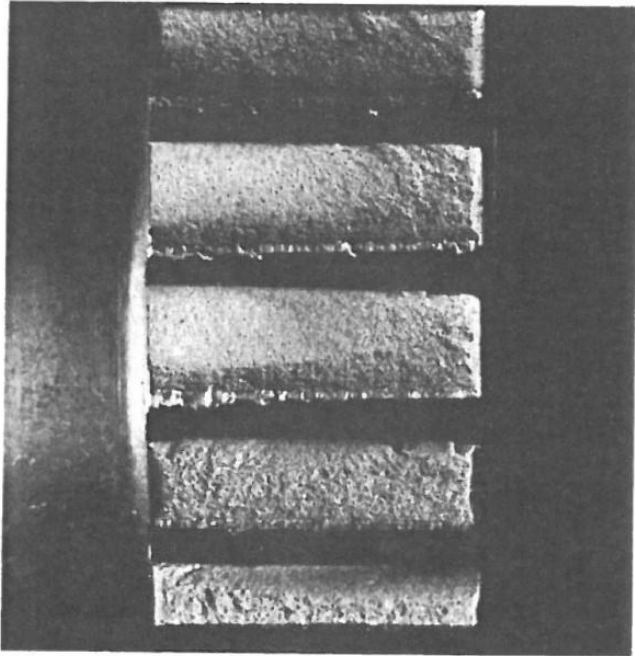
Overload Breakage: The break in this hardened and ground spur gear has a brittle fibrous appearance and the complete absence of any of the common beach marks associated with fatigue failure. In this case, one tooth failed from shock and the force was transmitted to successive teeth. As a result, several teeth were stripped from the rotating pinion.

An overload fracture results in a stringy, fibrous break showing evidence of having been pulled or torn apart. In harder materials the break has a finer stringy appearance but still shows evidence of being pulled apart abruptly.

Cause: Tooth breakage is caused by an overload which exceeds the tensile strength of the gear material; this results in a short-cycle break generally starting on the tensile side of the root fillet. Overload may result from a bearing seizure, failure of driven equipment, foreign material passing through the mesh, or a sudden misalignment from a failed or wiped gear bearing.

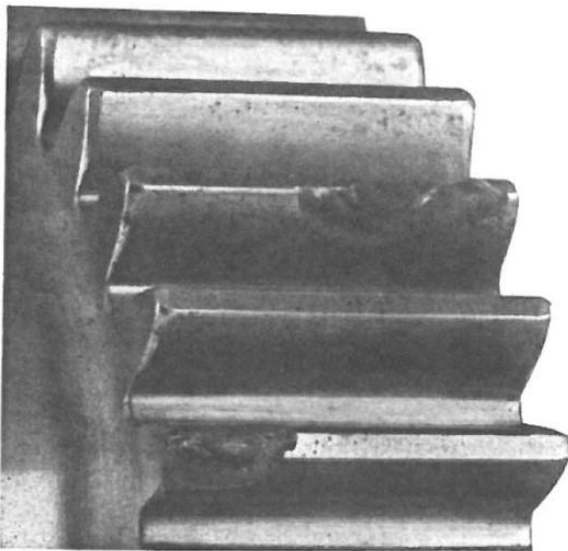
Random Fatigue Breaks: These breaks are not typical beam bending failures. They originate high on the tooth flank and are somewhat uniformly dispersed across the face of the gear. Failures of this nature originate from stress risers other than at the root fillet. In this installation, fatigue failure resulted from grinding cracks on the tooth flanks.

breakage failure can occur in other portions of the gear tooth. Sometimes, the top of a gear tooth will break away or large chips will fatigue away from the end of a tooth.

Cause: Failures of this kind are often caused by deficiencies in the gear tooth which result in a high stress concentration at a particular area. Often, flaws or minute grinding cracks will propagate under repeated stress cycling and a fracture will eventually develop. Foreign material passing through the gear mesh will also produce short-cycle failure of a small portion of a tooth. High residual stresses due to improper heat treatment can cause local fractures that do not originate in the tooth section.

Remedy: It is difficult to prevent failures of this type except by good design and manufacturing practices. If trouble is encountered, the gear surfaces should be checked for possible previous damage that may have contributed to local stress risers. The history of heat treatment and manufacturing techniques should be reviewed to ensure that proper processing was carried out during all steps of the manufacturing cycle. Cleanliness of the gear material should also be examined.

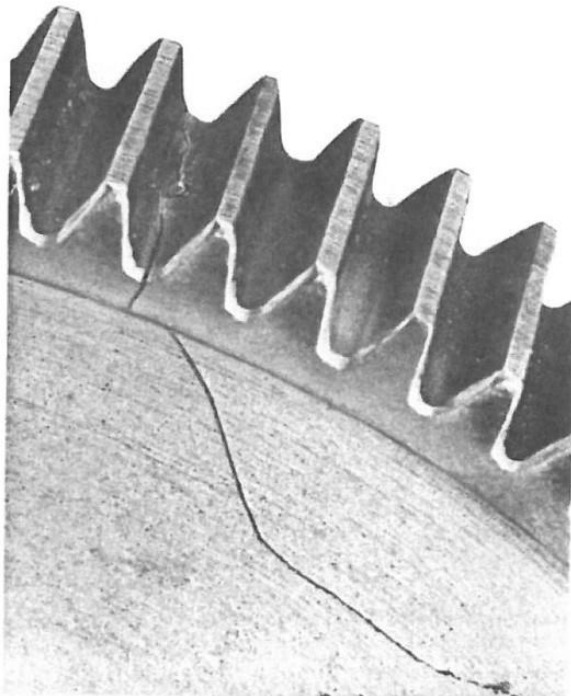
Rim and Web Failure: This hardened and ground spur gear fractured through the root section. The crack propagated from the root section into the web of the gear. Such failures are not uncommon on highly loaded thin rims and webs.

The rim of a gear usually fails between two adjacent teeth. Cracks propagate through the rim and into the web. Sometimes, cracks appear in the web near the rim and web junction without disturbing the rim itself.

Cause: Often, the failures are caused by flexure stresses in the gear teeth. If the crack starts from a high stress point, it may propagate through the rim instead of across the tooth at the root section. Web cracks may be caused by stress risers from holes in the web, or by web vibrations.

Remedy: If the gear fails through the rim, the rim thickness may be increased. The rim thickness below the root diameter should be a minimum of 1.5 times the whole depth of the root. Stress risers

in the root section—such as hob tears, grinding-wheel nicks, and grinding cracks—must be eliminated. If the web fails, increasing the web thickness may be helpful. All stress risers in the web area—such as deep tool marks, lightening holes in the web, and sharp fillets in the web-to-rim junction—should be eliminated.

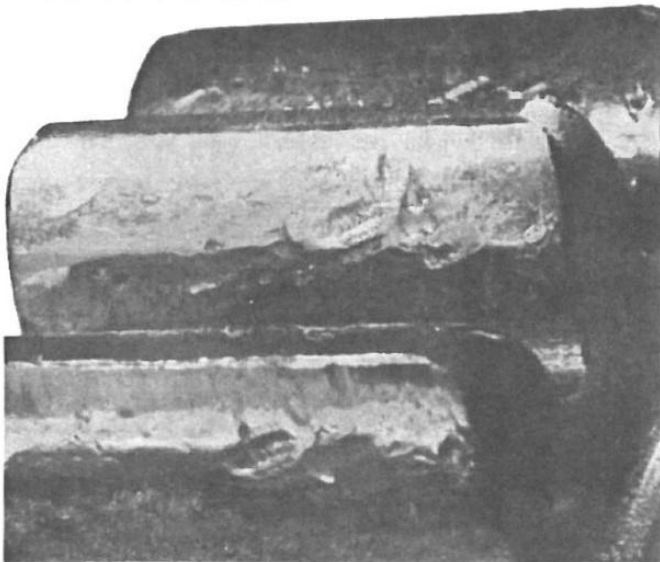
Cold Flow: This bevel gear shows an advanced stage of cold flow. Much material has been rolled out over the top edges of the gear teeth, resulting in complete destruction of the gear-tooth profile. The material of this gear was medium-hard; such a material has a greater tendency to flow than a case-hardened material.

In this type of failure, the surface and subsurface material shows evidence of metal flow. Often surface material has been worked over the tips of the gear teeth, giving a finned appearance. Sometimes the tooth tips are heavily rounded-over and a depression appears on the contacting tooth surface.

Cause: Under heavy load the rolling and peening action of the mesh cold-works the surface and subsurface material. The sliding action tends to push or pull the material in the direction of sliding, if the contact stresses are high enough. The dents

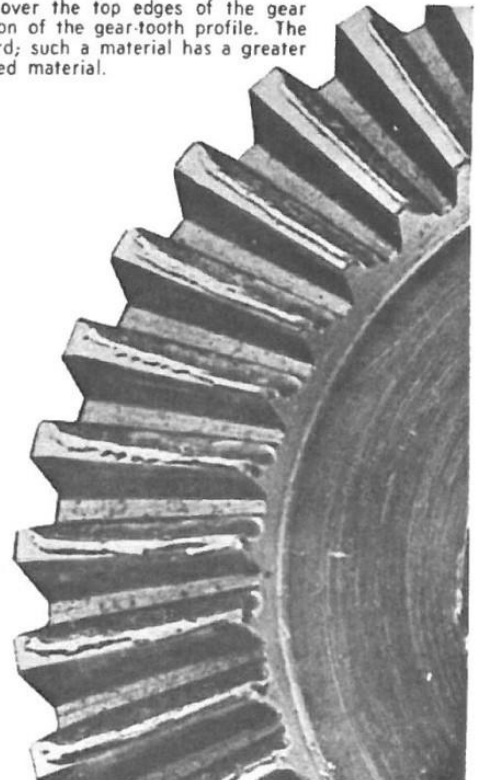
Cold Flow: This medium-hard spur gear shows signs of bad surface deformation due to rolling and peening action. This gear was operated long after the initial surface distress occurred, resulting in a battered cold-worked surface.

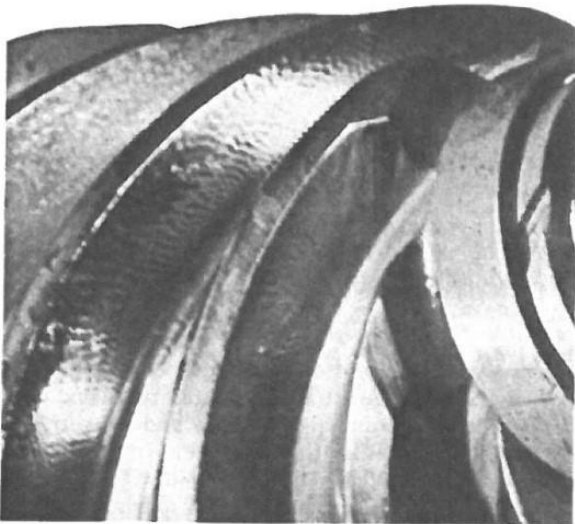
Rippling: A typical case of rippling appears on this hardened hypoid pinion. Note the waviness or fish-scale pattern. Rippling often shows up on highly loaded hypoid gears but can be produced on highly loaded spur gears as well.

This is a periodic wave-like formation at right angles to the direction of sliding or motion. It has a fish-scale appearance and is usually observed on hardened gear surfaces, although it can occur on softer tooth surfaces under certain conditions. Rippling is not always considered a surface failure, unless it has progressed to an advanced stage.

Cause: High contact stresses under cyclic operation tend to roll and knead the surface causing the immediate subsurface material to flow. Slow-speed operation is usually associated with this type

of failure, because it does not build up adequate elasto-hydrodynamic film thickness. This combination of high contact stress, repeated cycles, and an inadequate lubricating film will produce a rippled surface.

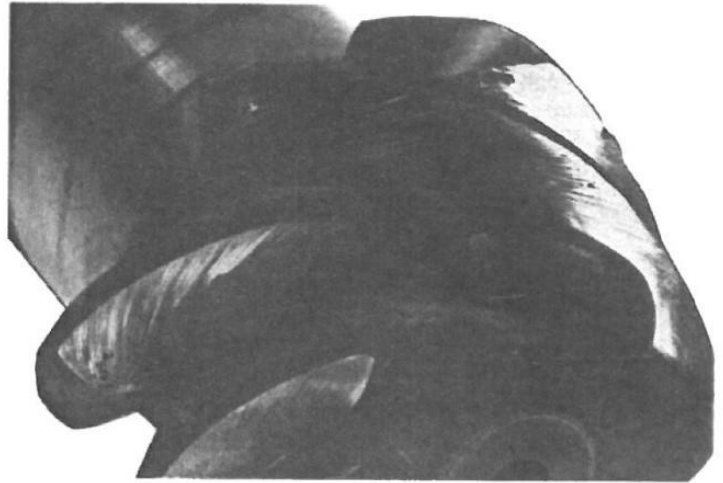
Ridging: On this hardened pinion, note that some wear has taken place and that some surface pitting is present although the predominant mode of failure is ridging.

This is the formation of deep ridges by plastic flow of surface and subsurface material. It shows definite peaks and valleys or ridges across the tooth surface in the direction of sliding.

Cause: Ridging is caused by the plastic flow of surface and subsurface material due to high contact compressive stresses and high relative sliding velocities. It is often present on heavily loaded worm

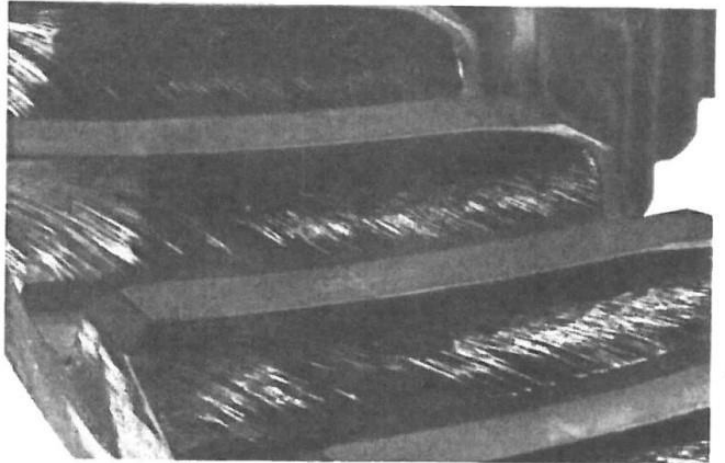
Ridging: This is an excellent example of how ridges form on the surface of a hardened gear. Although the surfaces are very hard, the ridges show a definite peak-to-valley effect in the direction of sliding.
